**Flood Control Project Maintenance
Levee Inspections**

Fall 2013 Levee Maintenance Deficiency Summary Report

Reclamation District No. 0404 Boggs

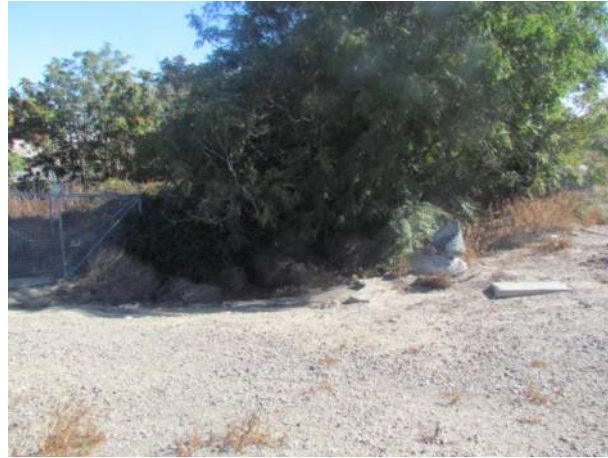
Levee Mile Report Line	33
Start Levee Mile	1.21
End Levee Mile	1.21
Location	Land Side
Category	Earthen Levee
Item	Encroachments

Looking southeast at old broken concrete pipes on landward slope and toe.

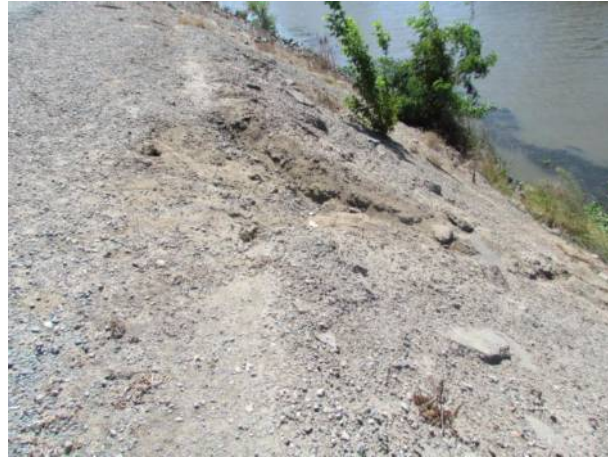
Looking southwest at slope damage due to foot traffic.

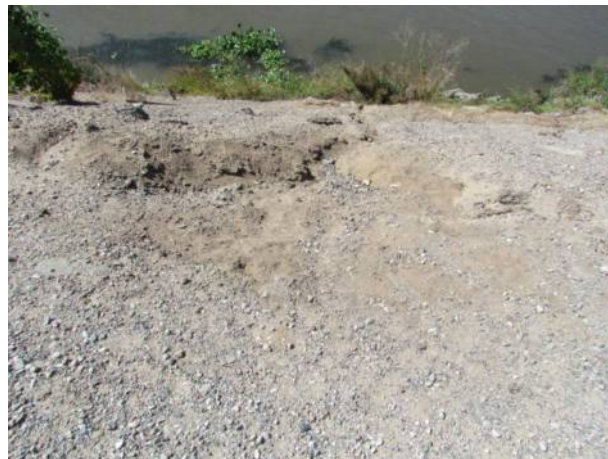
Levee Mile Report Line	50
Start Levee Mile	2.01
End Levee Mile	2.01
Location	Water Side
Category	Earthen Levee
Item	Slope Stability

Looking west at slope damage due to foot traffic.

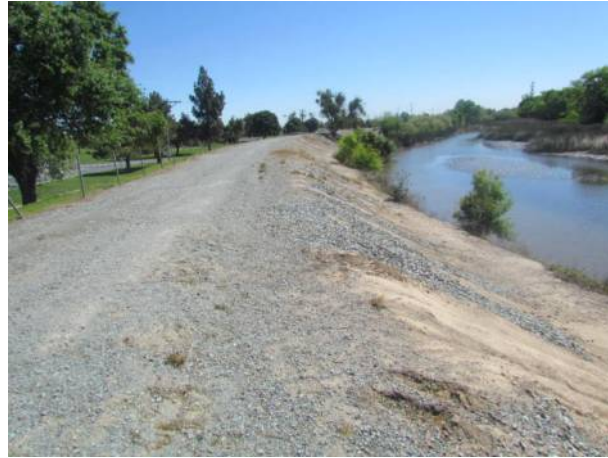
Levee Mile Report Line	37
Start Levee Mile	1.53
End Levee Mile	1.53
Location	Water Side
Category	Earthen Levee
Item	Slope Stability

Looking east at repaired site on waterward slope.
